MOBILE BAYKEEPER POLLUTION REPORT: Coal Ash at Alabama Power's Plant Barry

Prepared By:

Mobile Baykeeper

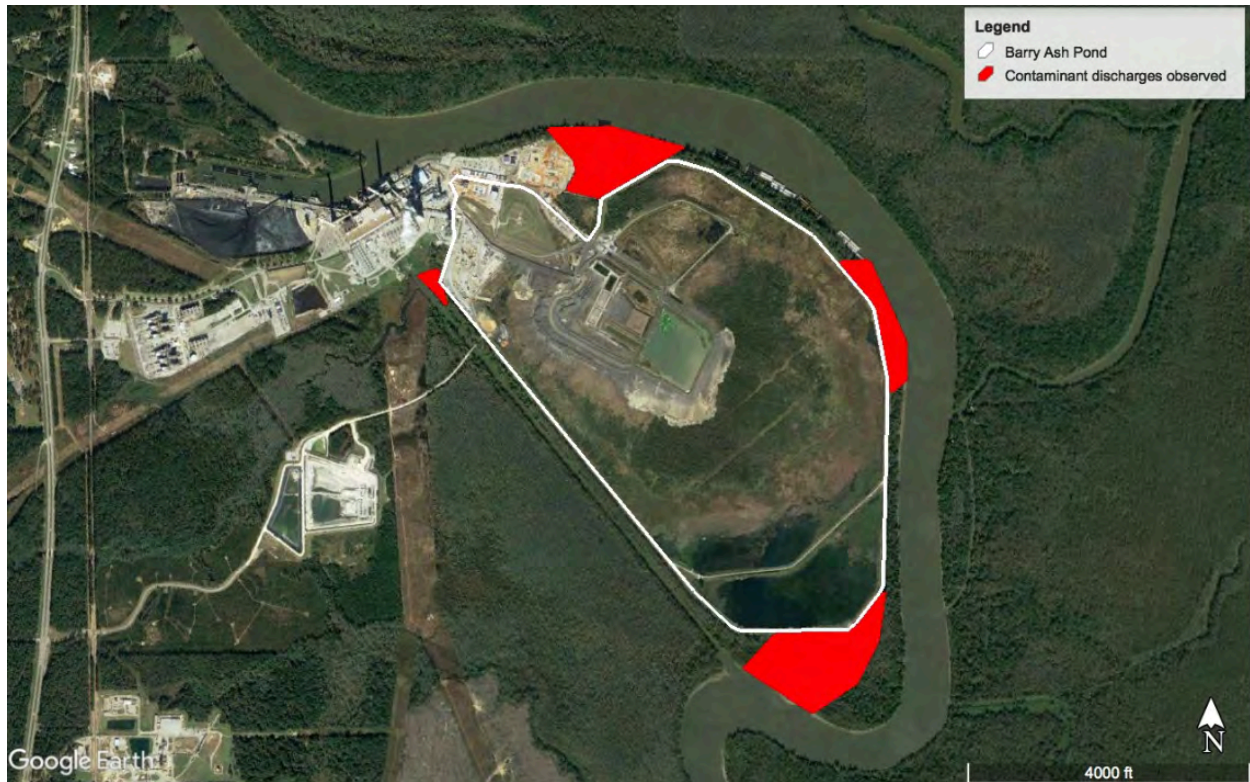
Figure 12. Map of contamination discharges identified at Plant Barry's ash pond.

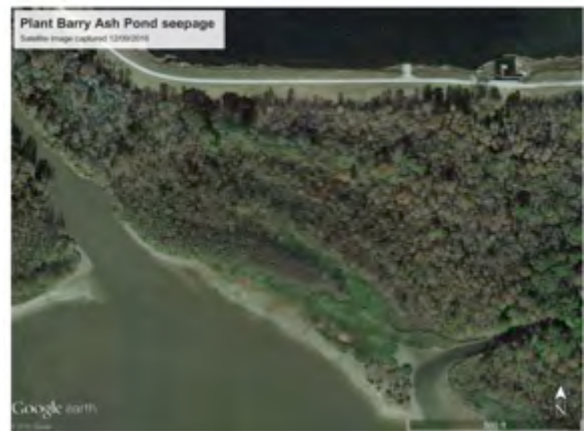
Figure 13. Satellite imagery showing seepage at Plant Barry's coal ash pond.

Global Environmental LLC report (attached as Appendix M) found a great deal of "visual and field probe device (conductivity) evidence that the surface impoundment is leaking below and/or through the dikes. That leakage becomes surface water flow in the exterior sides of the dike". The report also found numerous exceedances of regulatory standards.³³ The report notes that all sampling conducted showed common coal ash contaminants. The report identifies several areas where satellite and aerial imagery shows apparent leakage through the dam as well as suspected recent repairs.

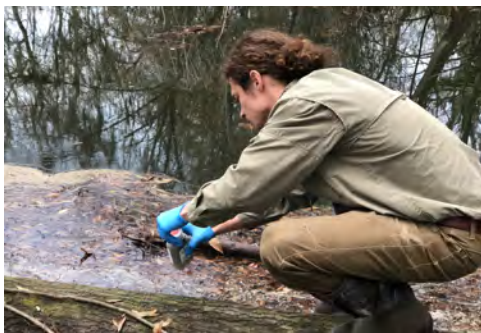
Figure 15. Mobile Baykeeper samples floating material later confirmed to be coal ash near Plant Barry's coal ash pond.

On February 4, 2016, Mobile Baykeeper observed floating fly ash in the backwater of the Mobile River, approximately 10 feet south of the southern tip of the ash pond. Samples were collected and sent to MVA Scientific Consultants for microscopic analysis.

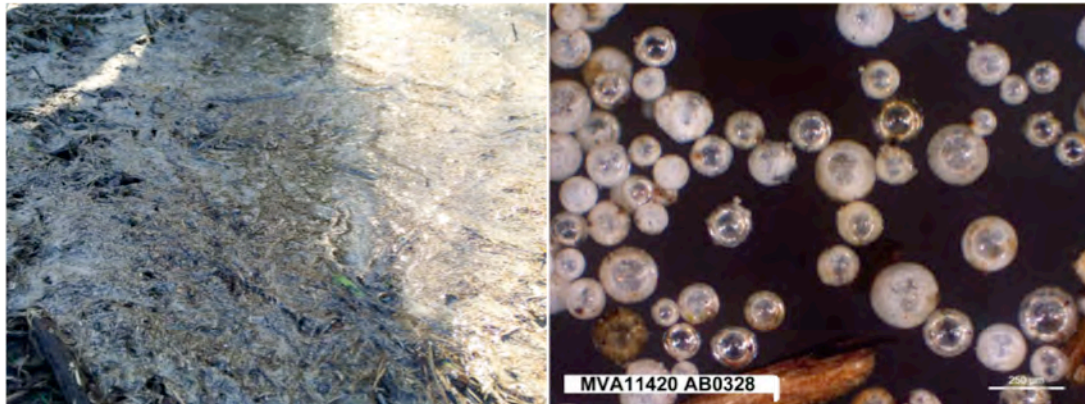
Results confirmed the material was 60-80% (by volume) fly ash, mostly comprised of floating cenospheres [tiny spheres that are byproducts of burning coal ash] (Figure 16). Approximately 20-40% (by volume) consisted of organic debris (primarily wood particles). Results clearly indicate a strong presence of floating fly ash. By allowing fly ash to be discharged from its ash pond, Alabama Power is violating its permit provision prohibiting the discharge of floating solids.

Figure 16. (Left) Material collected in the field, (Right) Polarized light microscope (PLM) image of fly ash cenospheres observed in collected sample.

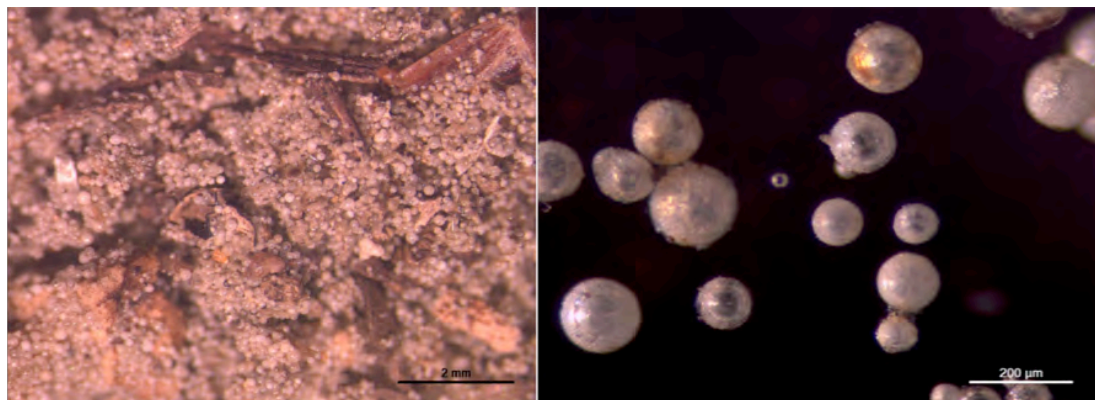
A similar situation was encountered on February 9, 2018. Mobile Baykeeper staff observed floating debris near the discharge outfall that had a consistence similar to the material observed on February 4, 2016. A sample was taken and sent off to MVA Scientific Consultants for microscopic analysis. Results indicated the material was “determined to be approximately 55-75% (by volume) fly ash, mostly floating cenospheres” (Figure 17). The remaining material consisted of wood and cellulose particles (20-40% by volume).

Figure 17. (Left) Stereoscope image of fly ash and plant material observed floating at the top of the sample, (Right) Polarized light microscope (PLM) image of fly ash cenospheres observed in collected sample.

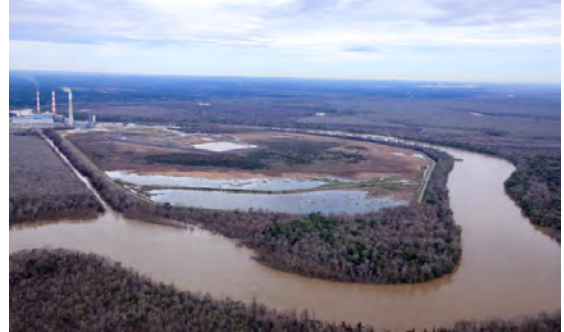
At certain times of the year and during high-water events, wetland and marsh areas surrounding the ash pond become submerged and standing water reaches the dam walls and may even overtop the dam walls of the ash pond.

Figure 18. Aerial showing a high water event at Plant Barry.

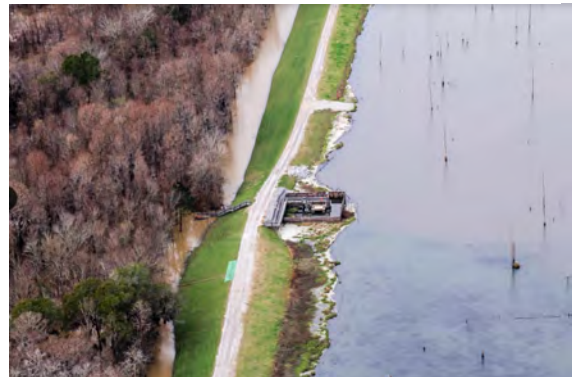
To illustrate this, Mobile Baykeeper conducted an aerial survey following a high-water event on February 3, 2016. Photo documentation from this day illustrates the water level within and outside of the pond rose to within a few feet of the top of the dam walls. According to rainfall records published for Mobile Regional Airport, located south of Plant Barry, this event occurred in response to approximately four inches of rainfall over the week prior to the photo being taken. These images illustrate how significant the potential for flooding is at the ash pond.

Figure 19. High-water event on February 3, 2016 with water levels approaching dam sides.

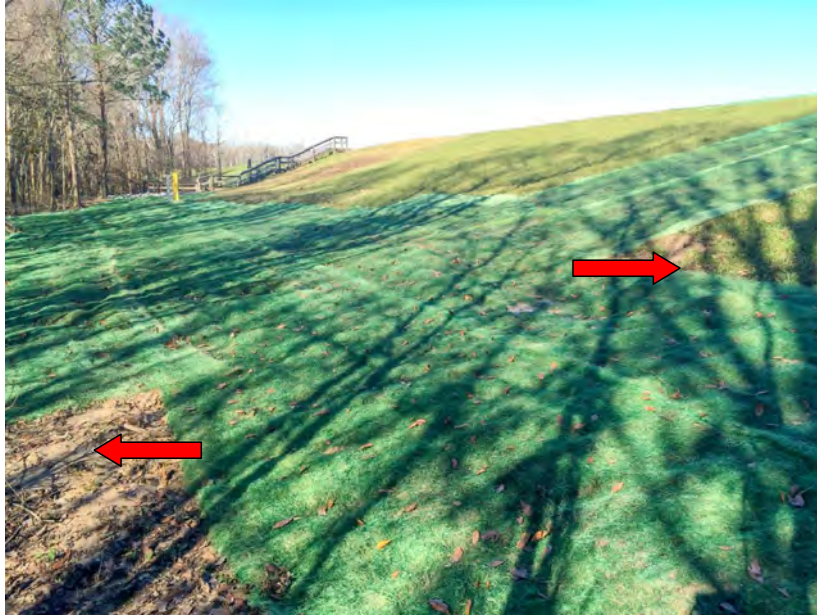
Photo 1: Evidence of Piping North of Pond Outlet (Feb. 4, 2016)

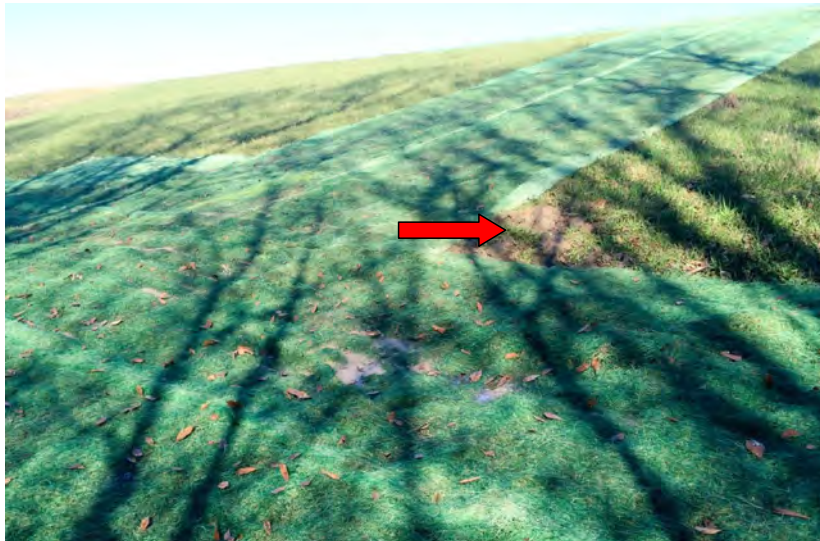
Photo 2: Evidence of Piping North of Pond Outlet (Feb. 4, 2016)

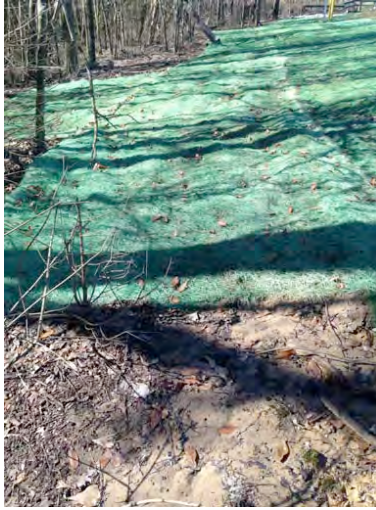
10. Exterior dike surfaces commonly had what seems to be bottom ash in their construction materials. Bottom ash is porous (leaks) and is not very cohesive (erodes easily).

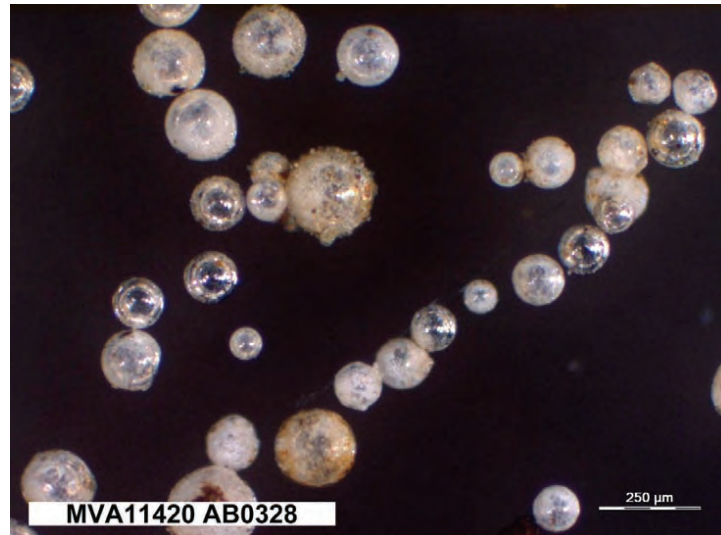
Figure 2. PLM image of fly ash cenospheres observed in sample AB0328.

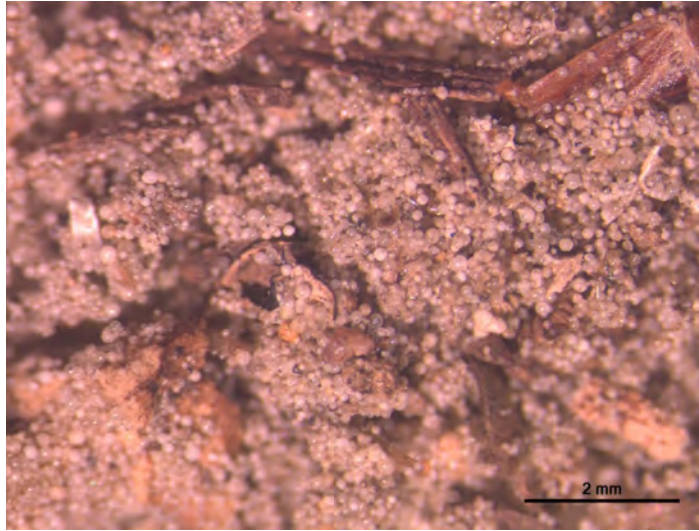
Figure 1. Stereoscope image of fly ash and plant material observed floating at the top of sample 12534AD0281.

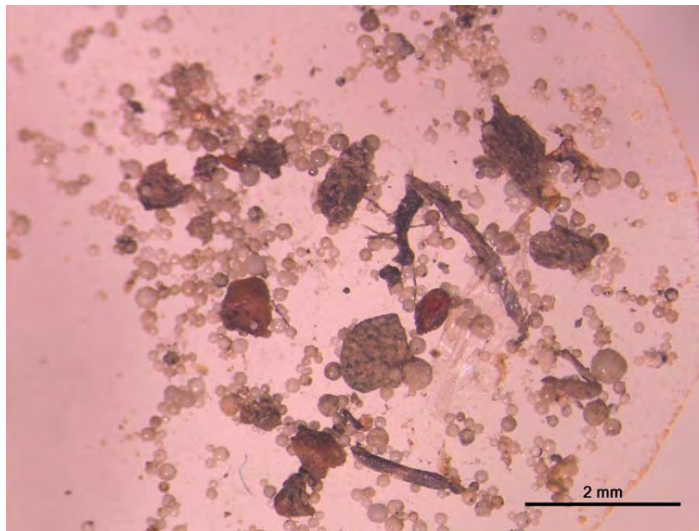
Figure 2. Stereoscope image of fly ash and plant material observed at the bottom of sample 12534AD0281.

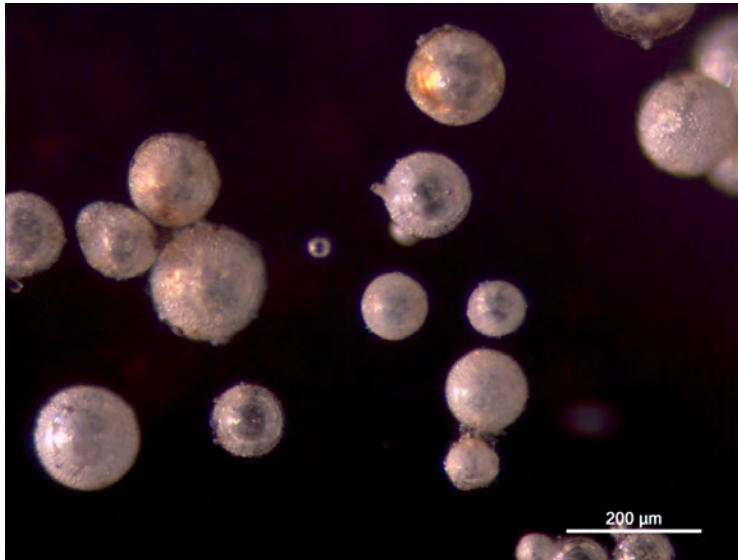
Figure 3. PLM image of fly ash cenospheres observed in sample 12534AD0281. Reflected (top) light illumination.

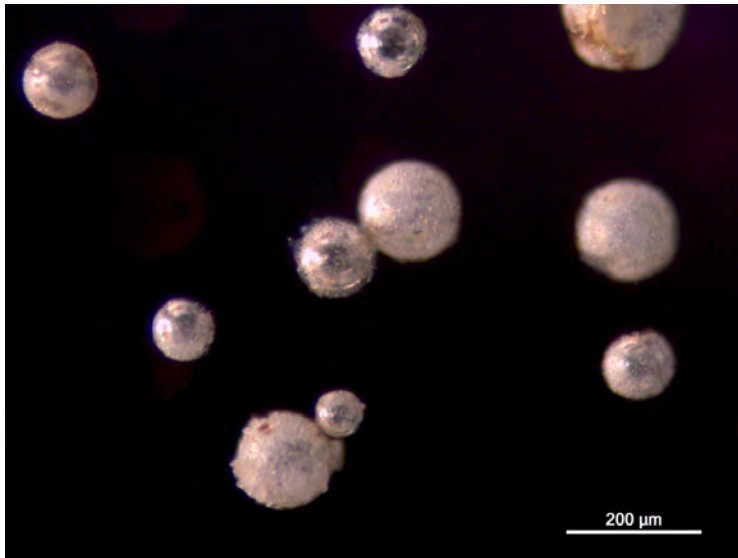
Figure 4. PLM image of fly ash cenospheres observed in sample 12534AD0281. Reflected (top) light illumination.
