MOBILE BAYKEEPER POLLUTION REPORT: Coal Ash at Alabama Power's Plant Barry

Prepared By:

Mobile Baykeeper

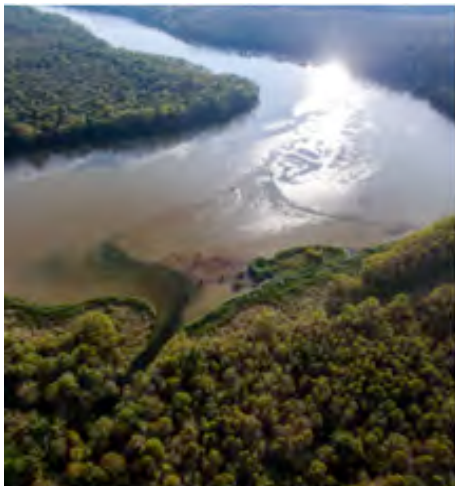
Figure 9. Wastewater is discharged from Plant Barry's permitted outfall into the Mobile River.

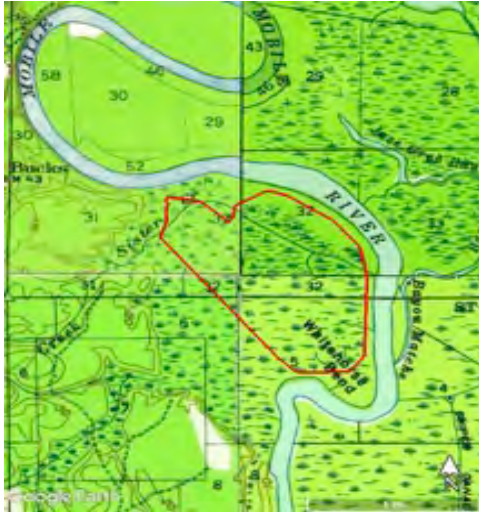
Figure 10. Historical topography from 1940 showing Sister's Creek flowing through where the ash pond now sits.

The ash pond is encircled by environmentally sensitive areas: it is bordered by the Mobile River to the east and south, and by the plant's manmade cooling water discharge canal to the west. The ash pond was built over a marsh area where Sisters Creek, a tributary to the Mobile River, used to flow (Figure 10).

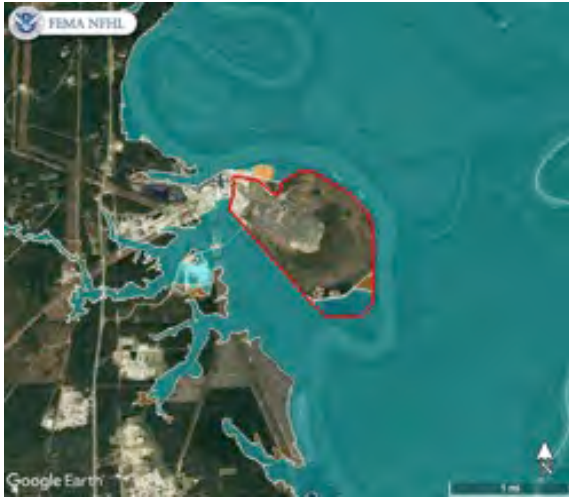
Figure 11. FEMA records showing the ash pond dam within the 100-year flood plain.

located within the ash pond, Alabama Power concurred, stating that although parts of the ash pond are outside the floodplain, the “current topographic elevations in and around the Barry Steam Plant site are located within the 100-year flood plain.”²⁵

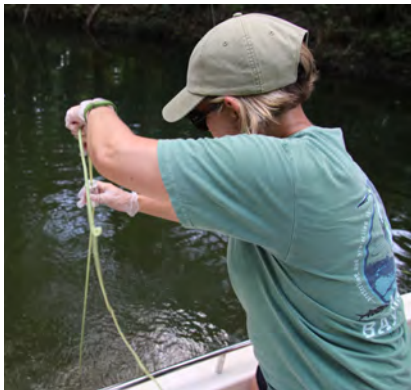
arsenic = 18 times the MQL
calcium = more than 20 times background
iron = 3 times background
manganese = 24 times background
potassium = almost 30 times background
sodium = almost 11 times the MQL

barium = almost 13 times background
chromium = almost 8 times the MQL
magnesium = 16 times background
nickel = 7 times the MQL
selenium = 3.5 times the MQL

Figure 14. Executive Director of Mobile Baykeeper taking a sediment sample near Plant Barry's ash pond.

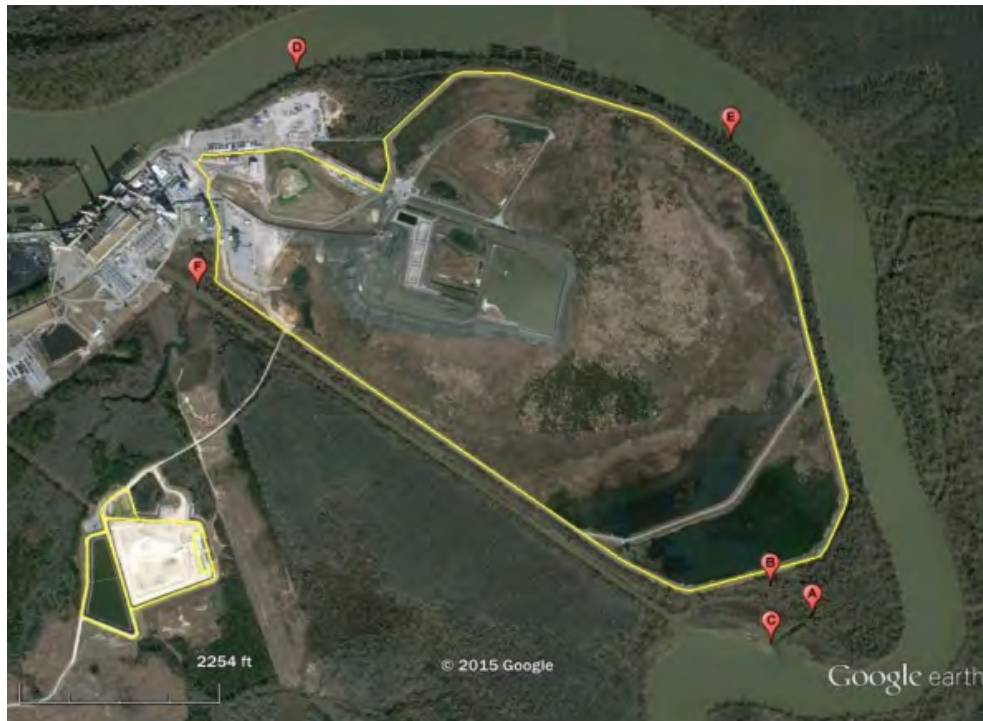
Mobile Baykeeper and Waterkeeper staff collected surface water samples on September 2, 2015 and sent samples to Pace Analytical Services for processing using EPA methods (200.7, 200.8, and 245.1). Samples were collected from six sites A) Surface Water Dry Channel - Toe of Dam, South, B) Toe of Dam, South, C) River, South, D) River Bank Seep, Northeast, E) River Bank Seep, East Dam, F) Sisters Creek Cooling Channel (as shown in Figure 20).

Figure 20. Surface water sampling sites.

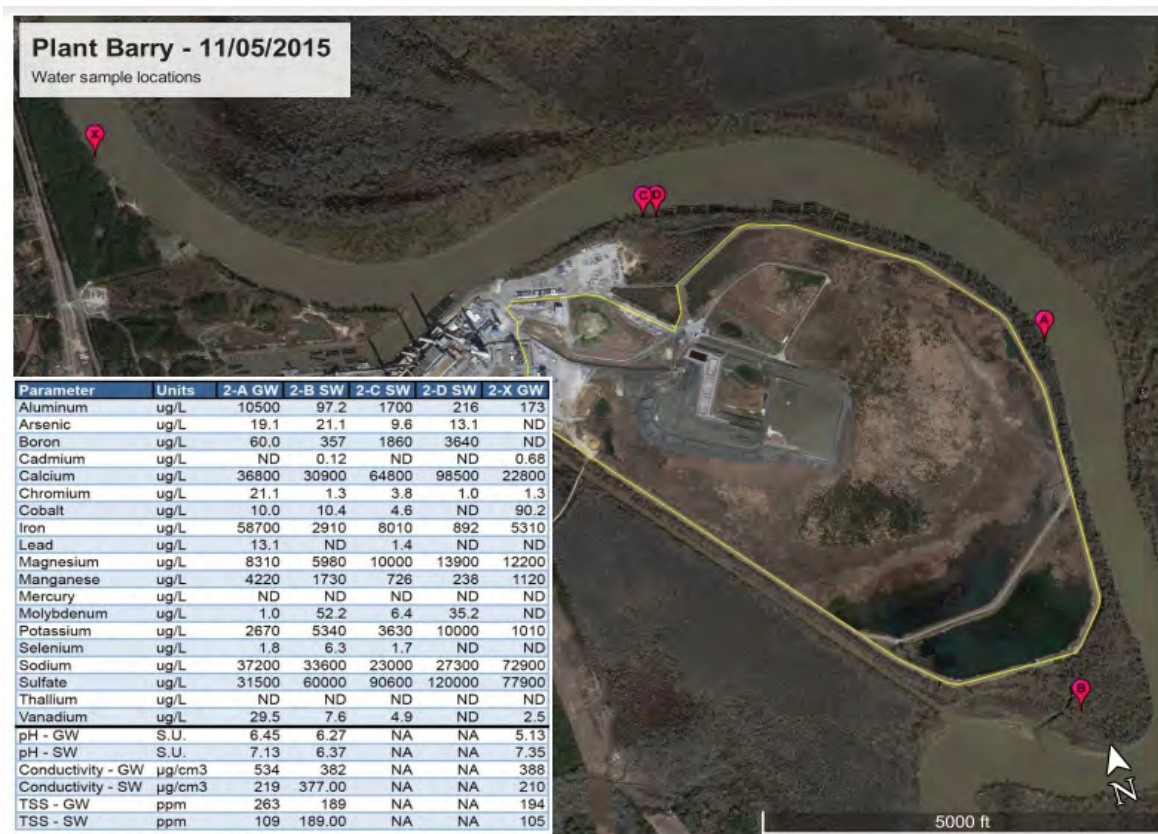
Additional surface water samples were taken by Mobile Baykeeper on November 5, 2015. These samples were sent to Pace Analytical Services for processing using EPA methods (200.7, 200.8, 245.1, and 300). Five sites were selected (Figure 21) A) Near River Bank, East, B) Surface Water Channel Downstream of Toe, South C) Surface Water Discharge from River Bank Seep, Northeast D Surface Water Discharge from River Bank Seep, Northeast.

Figure 21. Surface water sampling sites.

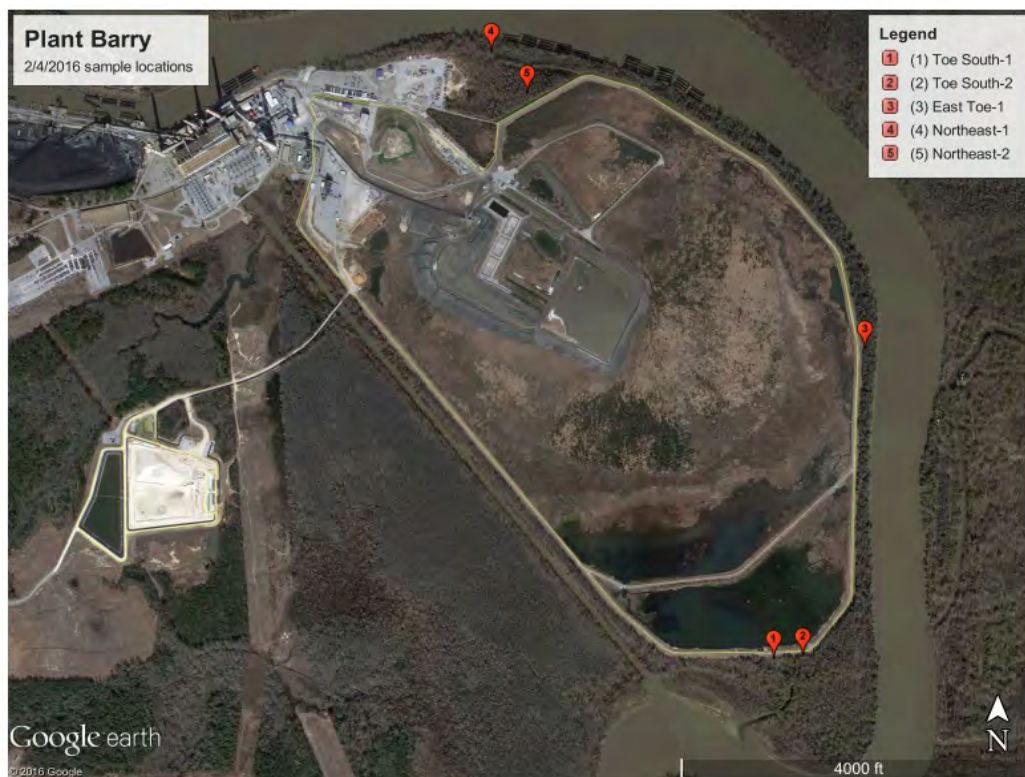
Surface water sampling was conducted by Mobile Baykeeper on February 2, 2016 and sent to Global Environmental, LLC for processing. Samples were collected from five sites 1) Seep through Dam; Toe of South Dam; 2) Seep through Dam, Toe of South; 3) Dam Surface Water Discharge, near Toe of East Dam; 4) Surface Water Discharge into Wetland, near Northeast Dam; 5) Surface Water Discharge near Northeast Dam (Figure 22).

Figure 22. Surface water sampling sites.

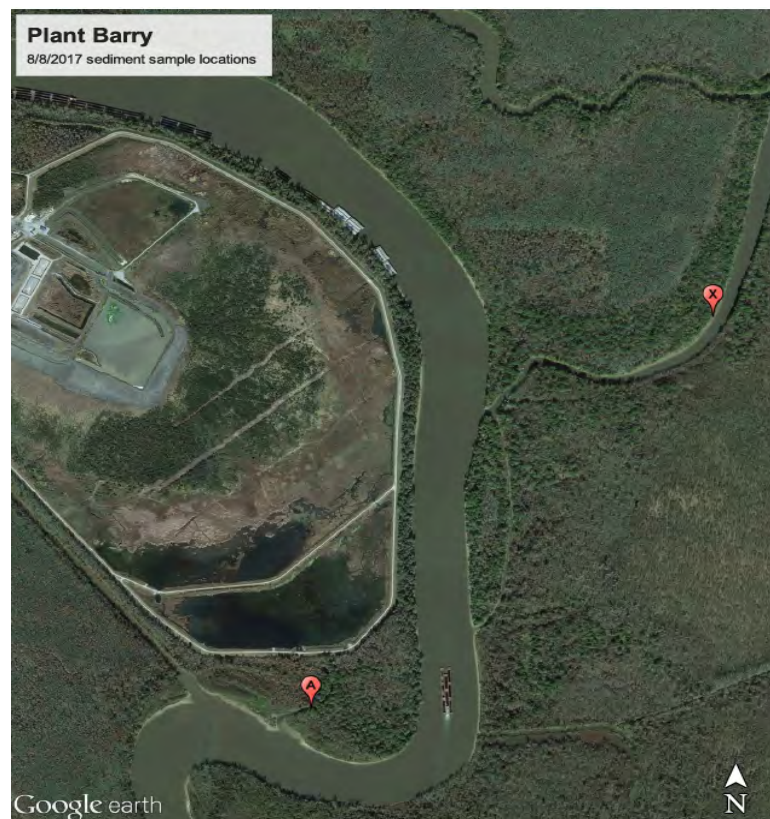
Mobile Baykeeper collected sediment samples from two locations: one to show the potential impact from the coal ash pond referred to as A) Canal and a upgradient location to compare values, referred to as X) Background (Figure 23). Samples were collected using a AMS shallow water bottom dredge and sent to Pace Analytical Services for processing. Pace Analytical used EPA methods: 6010 and 7471.

Figure 23. Sediment sample sites.

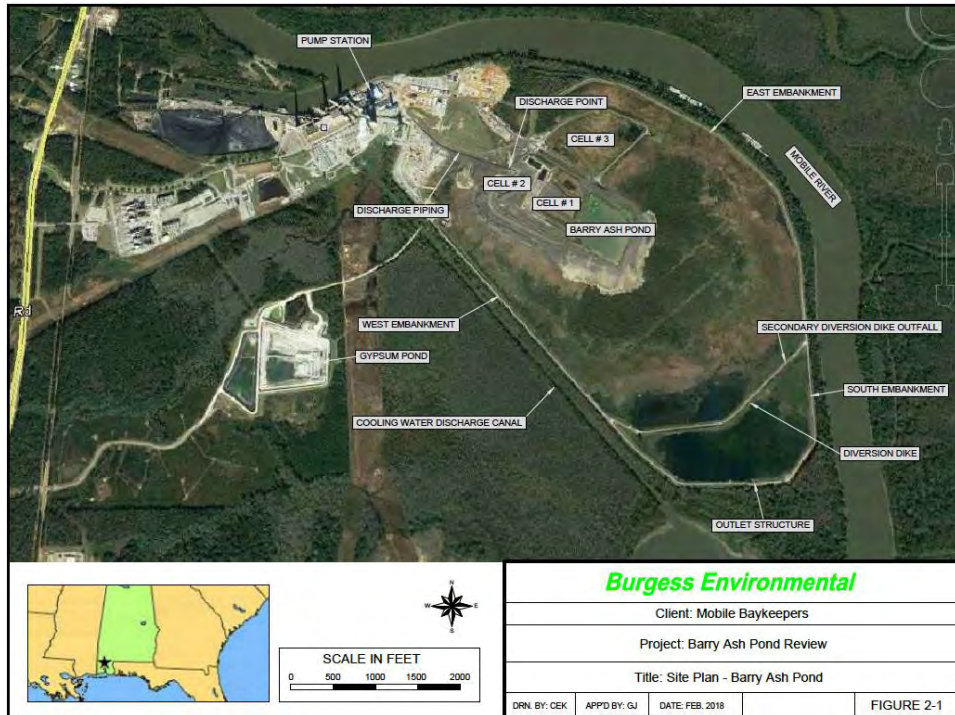
Figure 2-1
Site Plan - Barry Ash Pond

The Barry Ash Pond is located southeast of the power generating complex (Figure 2-1). The pond is bounded to the north by the Plant, to the east and south by the Mobile River, and to the west and southwest by the Plant cooling water discharge canal. Through essentially all of its history the Barry Ash Pond has not been subject to regulatory oversight.

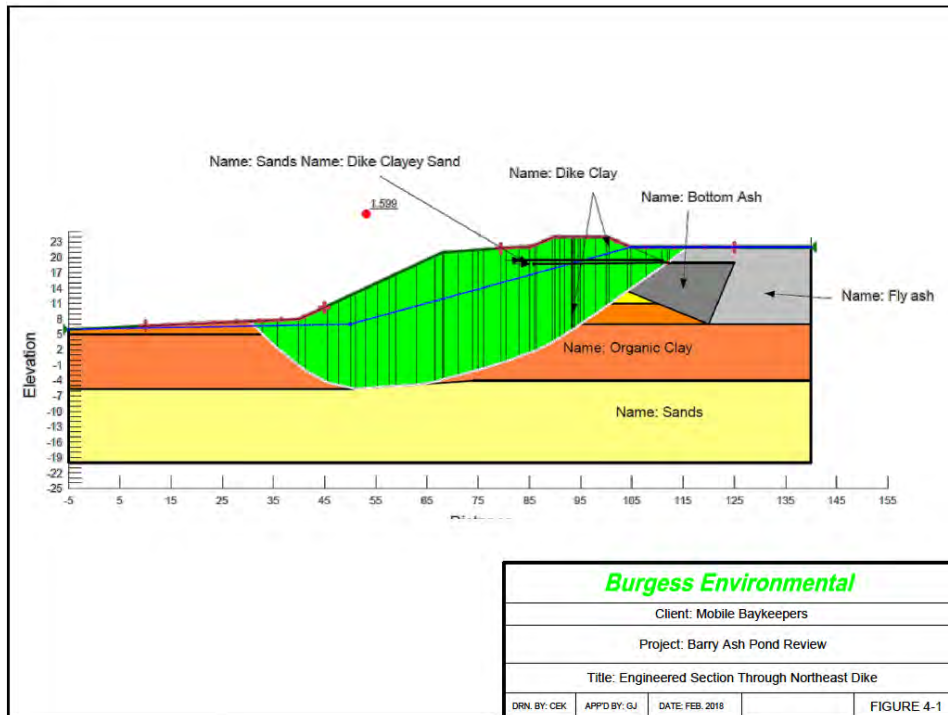
Figure 4-1
Engineering Section Through Northeast Dike

The dikes were constructed primarily on organic clay, which is in turn underlain by alluvial sands. The dikes are reported to be constructed using clay and clay sand, with some bottom and fly ash used in portions of the dike construction. Soil properties used in the analyses are summarized in Table 4.1. The Pond was assumed to be full of bottom and fly ash, and the water level was assumed to coincide with the elevation of the top of the dike. A schematic view of the dike cross-section used in the stability analysis is presented in Figure 4-1.

there is evidence of potential for piping as discussed in Section 5.4 of this report. Further, Mr. Pegues concluded that there were no risks associated with the dikes because the perimeter dikes were properly compacted. It is not clear how this conclusion was derived given that the early construction activities do not appear to have been supported by proper engineering drawings, construction specifications or QA/QC data.

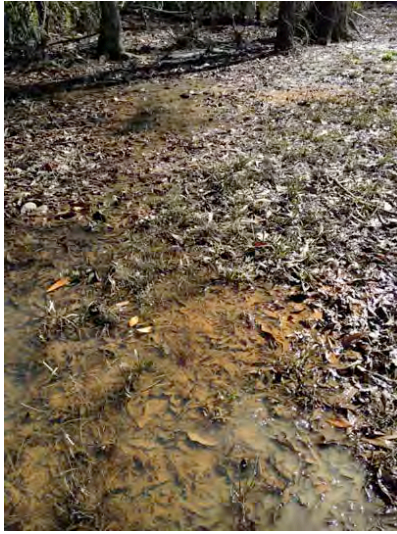
1. There is plenty of visual and field probe device (conductivity) evidence that the surface impoundment is leaking below and / or through the dikes. That leakage becomes surface water flow on the exterior sides of the dike. Flow is especially significant to the east and northeast. Those areas had considerable surface water flow going *away from* the toe of the dike.

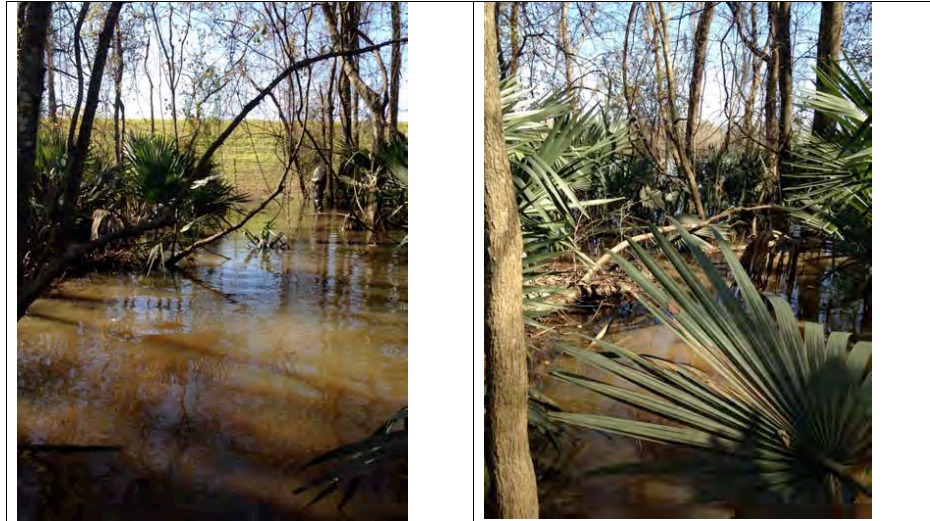
5. Water from the impoundment dike perimeters flowed into the Mobile River where there was a direct access channel (e.g. East Toe -1 sample locations, see photos below looking towards the impoundment and then towards the river) or complete backwater connection to the River. Other flows went to wetland / marsh areas with

no obvious channel connection to the Mobile River, while others are indirectly connected through unidentified surface water flow courses.

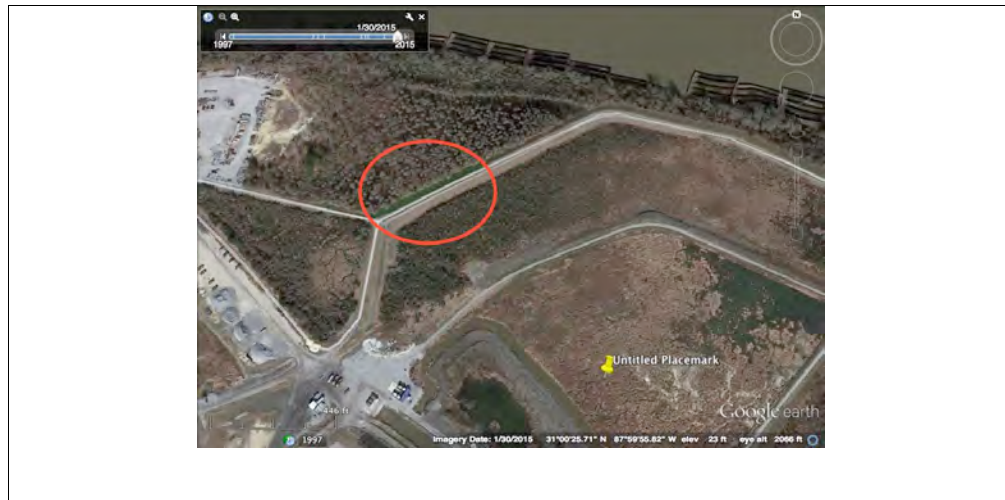
6. Samples collected by Waterkeeper of groundwater seeps along the exposed bank of the Mobile River and emergence points where water flows from the ground are all indicative of “groundwater”.
7. Aerial photos show areas of suspect dike leakage or repair areas where grass is especially green (from nutrients) or from repairs with green mats. These are most prominent on the eastern and northern dikes.

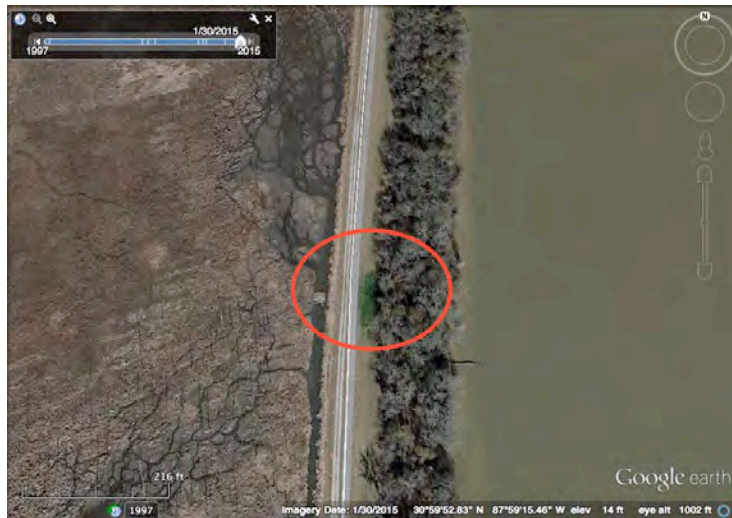
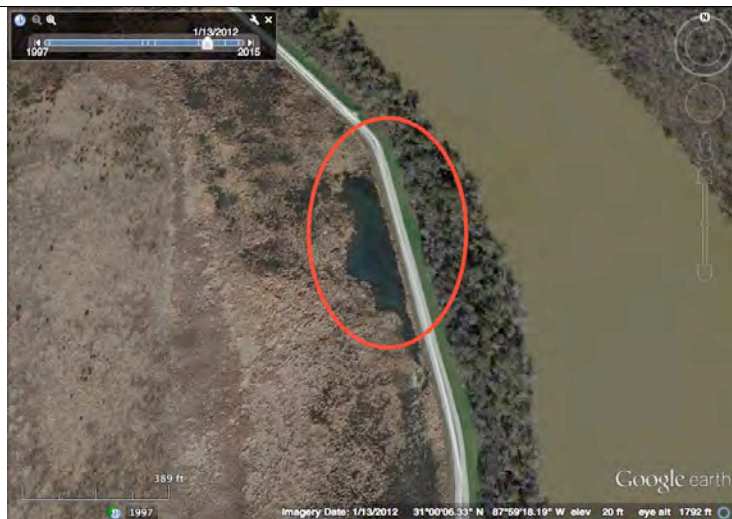
8. Groundwater (“GW”) samples and Surface Water (“SW”) sample results can be skewed high if the results have high suspended solids due to shallow water and human agitation during collection. Water samples Toe South-1 and Toe South-2 had high turbidity.
9. Dike repairs to the south were considerable and were recent, as evidenced by erosion control mats. Beneath the mats, one could see channelized flow – which is a sign that usually initiates more repairs are needed because such flows can result in “piping” of the dike and higher likelihood for failure.
